Left Coast Inspections

Property Inspection Report

Inspection prepared for:
Date of Inspection: 6/26/2017

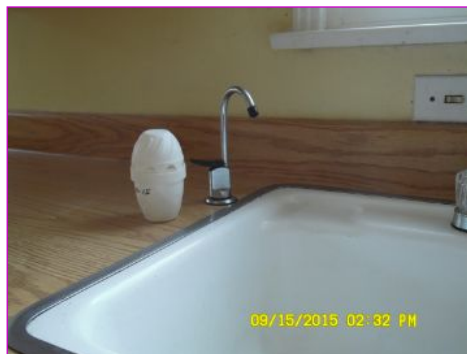
- At the time of the inspection, the Inspector observed few deficiencies in the condition and operation of the kitchen sink. Notable exceptions will be listed in this report.
- The kitchen sink had functional flow and functional drainage at the time of the inspection.
- The kitchen sink faucet appeared to be in serviceable condition at the time of the inspection.
- The wand was missing at the kitchen sink.

filtered water spigot not connected.

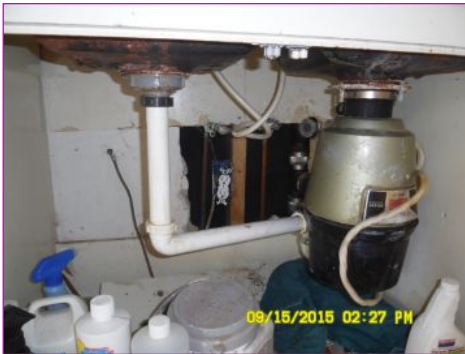
- At the time of the inspection, the Inspector observed few deficiencies in the condition and operation of undersink plumbing in the kitchen. Notable exceptions will be listed in this report.
- **Leaking connections at the trap assembly beneath the kitchen sink should be repaired to avoid future/additional damage to the cabinet floor and possibly the wall/floor structures below. The Inspector recommends repair.**
- **The wall behind the kitchen sink cabinet had large section removed. Recommend repairs be completed.**

Hole in wall.

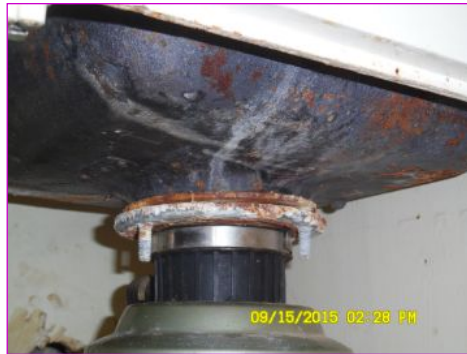
drain rusty at disposal neck.

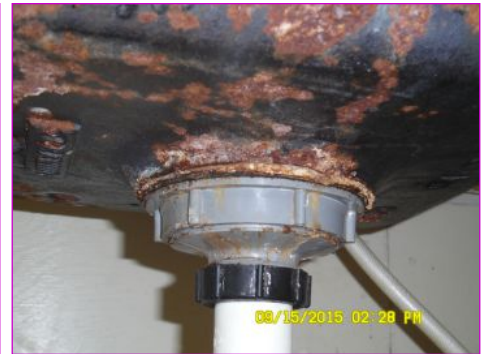
drain basket rusty.

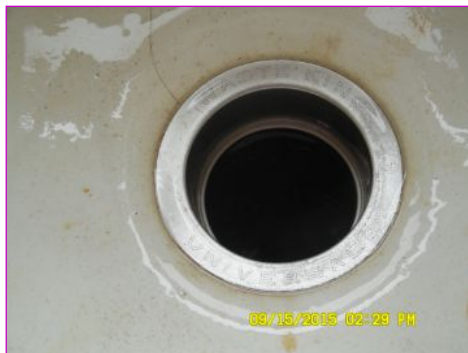
missing disposal gasket

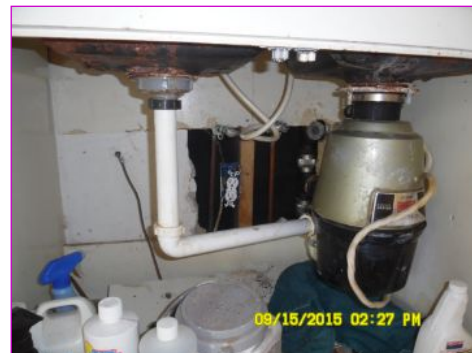
- The electrical connection to the garbage disposal was improper at the time of the inspection. The disposal should either be powered by an approved appliance cord plugged into a dedicated outlet, or be wired directly to a 20-amp overcurrent protection device like a breaker or fuse. Properly spliced connections should be housed within a junction box with a listed cover installed. This condition should be corrected.

not connected to power.

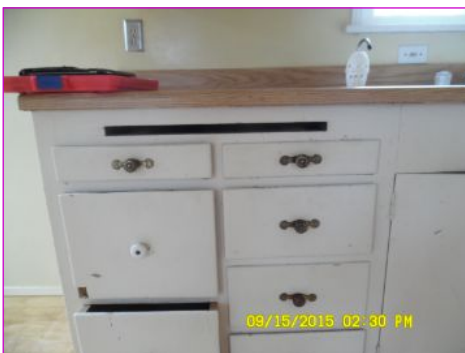
Breadboard missing

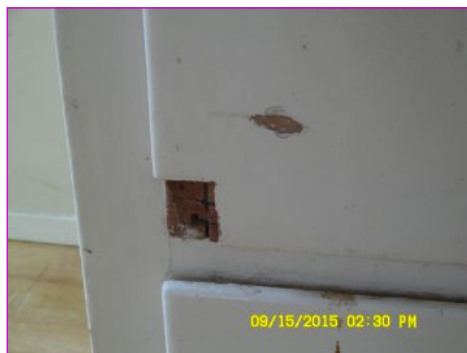
corner of drawer broken off.

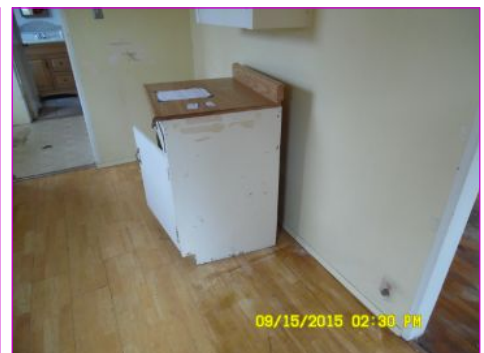
cabinet not secured to wall

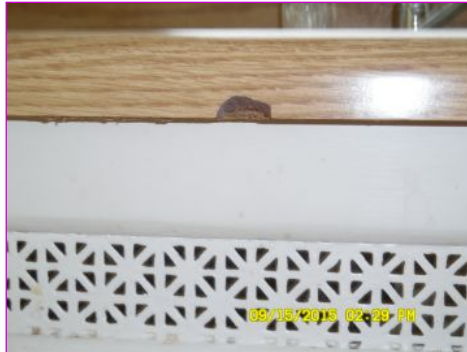
chip in counter top

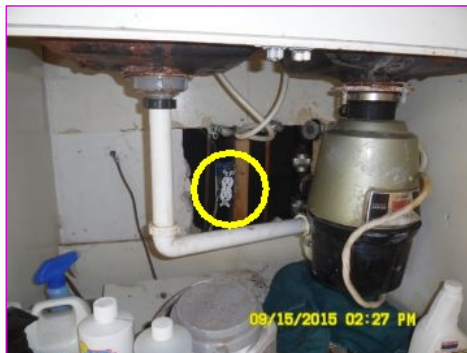
- **An electrical receptacle for the disposal in the kitchen was missing a cover plate. This condition left energized electrical components exposed to touch. This shock/electrocution hazard should be corrected.**
- **An electrical receptacle for the disposal in the kitchen was loose and moved when a plug was inserted. This condition should be corrected.**

Outlet not secure, no plate.

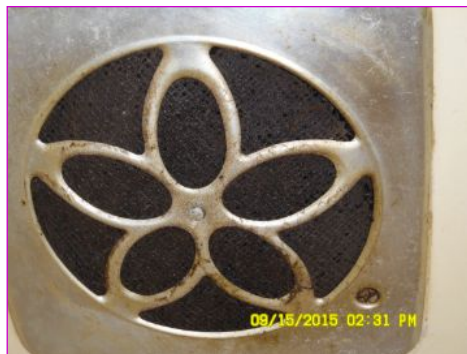
- The exhaust vent of the range hood discharged exhaust to the home exterior.
- The range hood filters needed cleaning at the time of the inspection.

vent needs cleaning or replacement

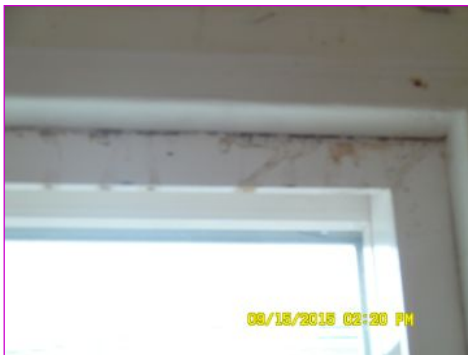
Both south windows in the living room exhibited signs of leaking water. The Inspector recommends that you consult with a qualified contractor to discuss options and costs for repair or replacement.

past leak at top of window

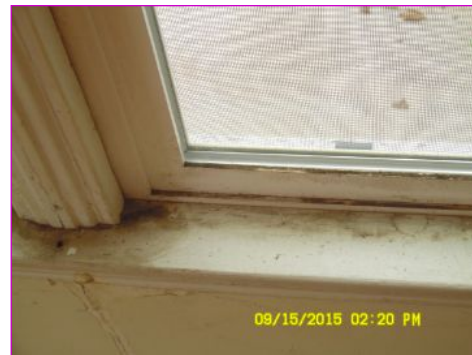
evidence of past leak at window sill

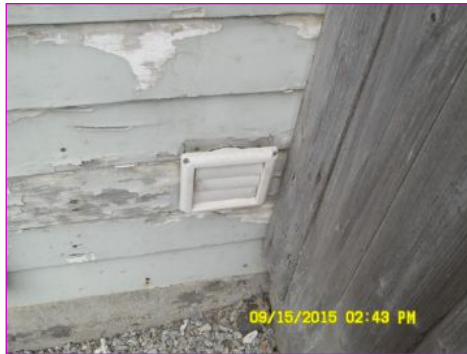
- **Dryer vent plate was not properly connected to outside of house. Recommend connecting and sealing.**

dryer vent not secured/sealed to wall

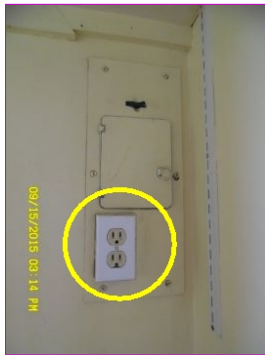
- An electrical receptacle in the laundry room was improperly wired. This hazardous condition should be corrected.

Outlet is not allowed to be installed on panel cover.

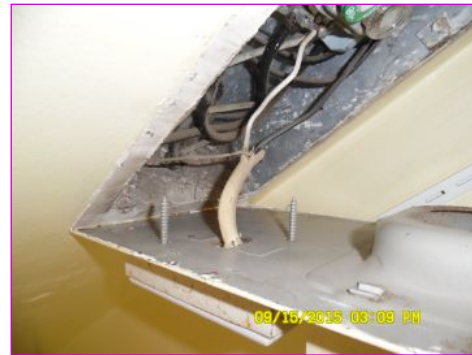
outlet installed on panel cover, not allowed and unsafe.

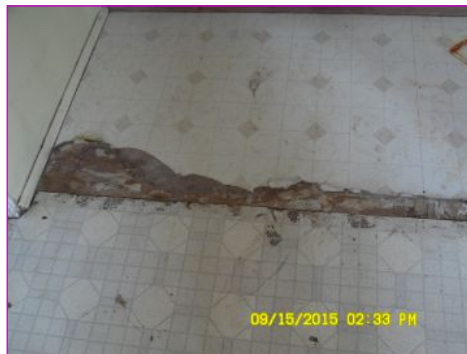
- At the time of the inspection, the Inspector observed few deficiencies in the condition of floors in the home. Notable exceptions will be listed in this report.
- The laundry room had severe vinyl floor damage visible at the time of the inspection. The Inspector recommends that you consult with a qualified contractor to discuss options and costs for replacement.

vinyl deteriorated

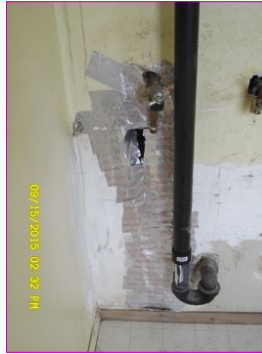
- At the time of the inspection, the Inspector observed no deficiencies in the condition of walls in the laundry room.
- Interior walls in the laundry room exhibited minor damage or deterioration at the time of the inspection.
- Interior wall in the laundry room next to the washer drain pipe had long hole that was taped over at the time of the inspection. The Inspector recommends correction.

hole in wall taped up

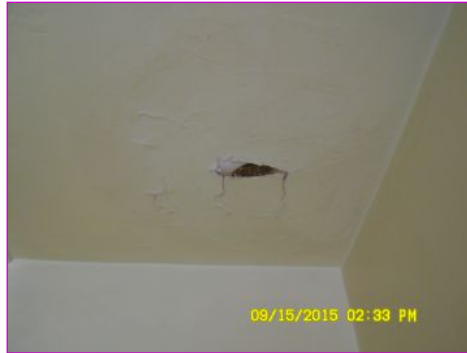
- Minor damage to the ceiling was visible in the laundry room at the time of the inspection.

Patch of hole coming apart.

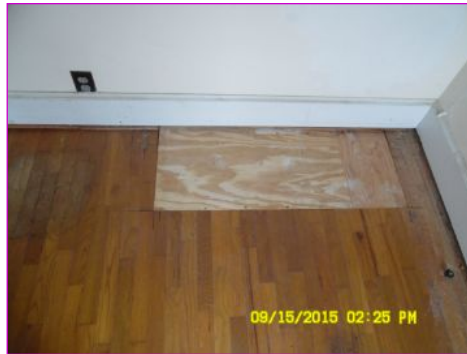
Observations: At the time of the inspection, wood floors in this bedroom exhibited areas of severe surface wear and some damage.

The floors needed some repair and refinishing.

Temporary floor repair

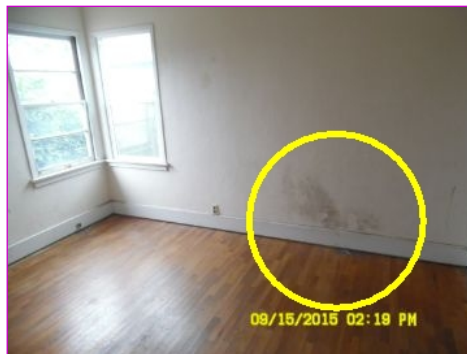
Stains on the walls in this bedroom visible at the time of the inspection appeared to be the result of moisture intrusion. Despite recent rain, the moisture meter showed no elevated moisture levels in the affected areas at the time of the inspection. This condition indicated that the source of moisture has been identified and corrected.

Some water stains on wall

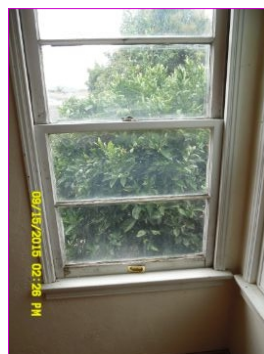
Observations: Window trim in this bedroom needed maintenance. All work should be performed by a qualified contractor.

original window

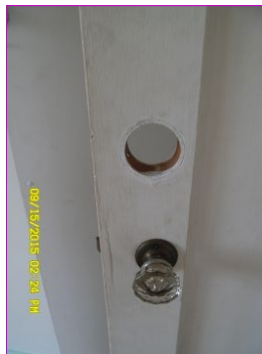
Observations: Door had hole for deadbolt but hardware was missing at an interior door in this bedroom. The Inspector recommends service by a qualified contractor.

deadbolt missing

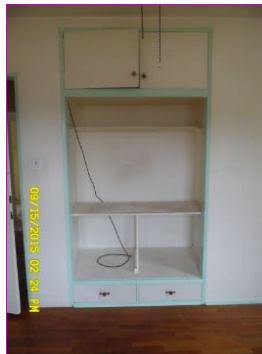
Observations: There were no closet doors installed.

doors missing

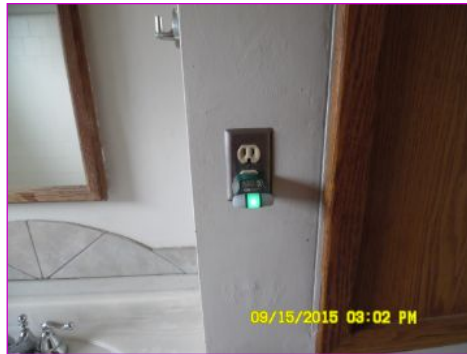
- At the time of the inspection, the Inspector observed no deficiencies in the condition of electrical receptacles, but they had no ground fault circuit interrupter (GFCI) protection. For safety reasons, consider having GFCI protection installed for receptacles within 6 feet of a plumbing fixture. This can be achieved by:

No GFI outlet in bathroom

1. Replacing the current standard receptacle with GFCI outlets
2. Replacing the receptacle nearest the overcurrent protection device (breaker or fuse) with a GFCI receptacle.
3. Replacing the breakers currently protecting the room electrical circuits with GFCI breakers.

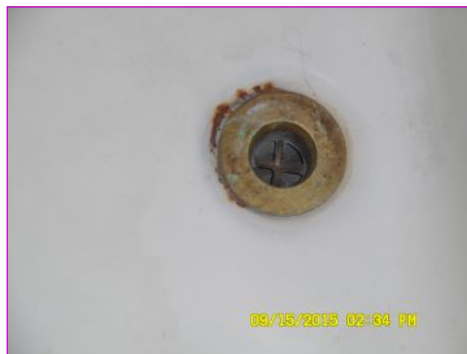
- At the time of the inspection, the Inspector observed few deficiencies in the condition of bathtub components. Notable exceptions will be listed in this report. Tub inspection includes testing for:
 - Functional flow;
 - Functional drainage; and
 - Operational shut-off valves, faucet, and diverter valve
- **The tub in this bathroom had minor damage visible.**

rust around drain

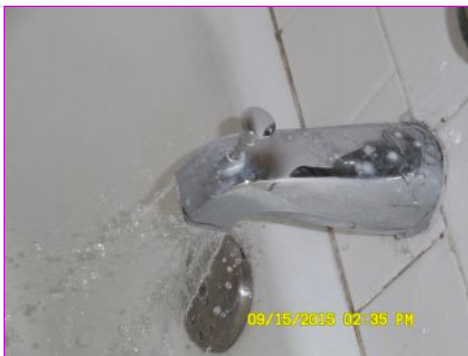
• **In this bathroom, the diverter valve was inoperable or did not operate correctly (the diverter is the valve which diverts water from the tub faucet to the shower head). The inspector recommends service.**

diverter does not completely seal on shower mode

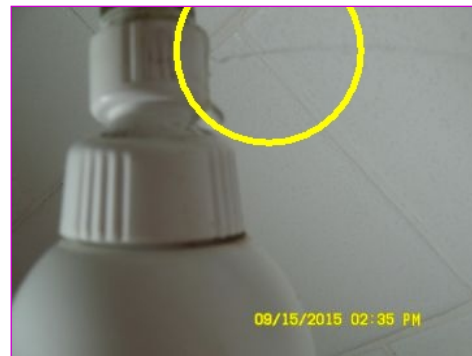
• **The showerhead connection leaked when the shower was operated. The inspector recommends service.**

shower head connection leaks

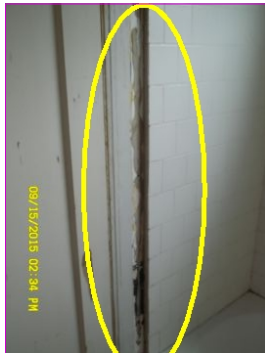
Tile edge not finished

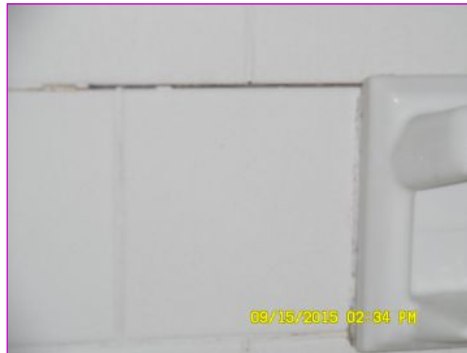
• **The shower tiles had areas of missing grout that may allow moisture to penetrate the walls.**

tile needs grout repair/sealing

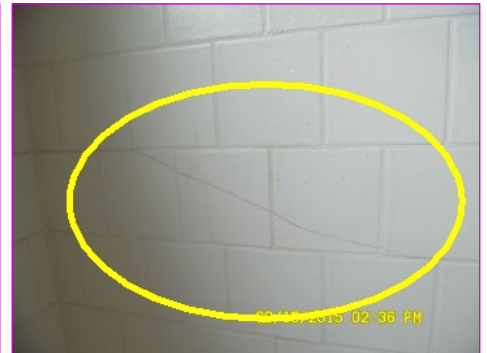
cracked tiles

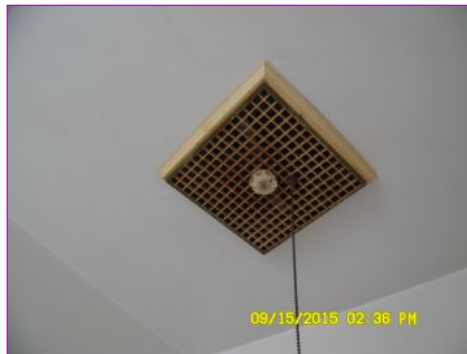
- The bathroom exhaust fan did not respond to switch at the time of the inspection and may need to be replaced.

fan did not respond to switch.

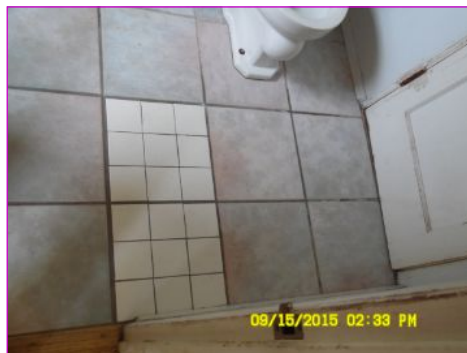
mismatched and cracked tiles

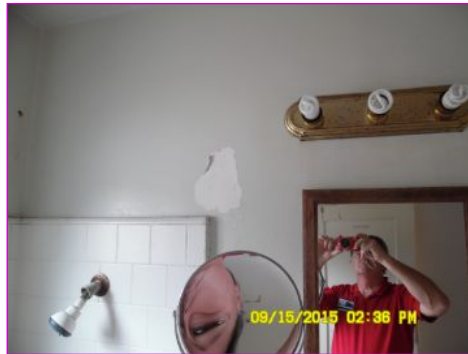
- At the time of the inspection, the Inspector observed few deficiencies in the condition of the bathroom walls. Any exceptions will be listed in this report.
- Interior walls in this bathroom exhibited general minor damage or deterioration at the time of the inspection.

paint peeling off wall

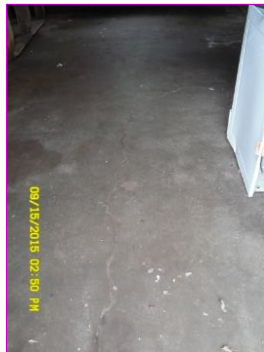
- At the time of the inspection, the Inspector observed few deficiencies in the condition of the garage floor. Notable exceptions will be listed in this report.
- The garage floor had common shrinkage cracks. These cracks are not a structural concern.

common slab crack

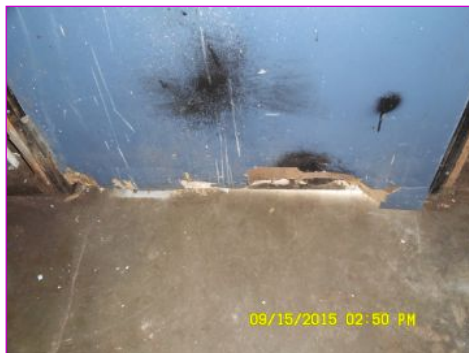
- The conventional door between the garage and the exterior was severely damaged and/or deteriorated and needed repair or replacement at the time of the inspection. The Inspector recommends that you consult with a qualified contractor to discuss options and costs for repair or replacement.

door deteriorated

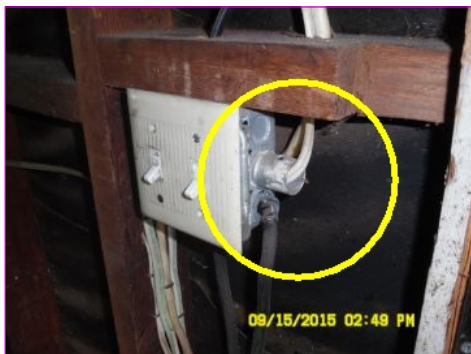
- All electrical receptacles in the garage were 3 prong outlets. Tester showed no actual ground at the time of the inspection. This hazardous condition should be corrected.
- Wiring at the garage light switch was not properly installed. Wires should be properly secured.
- Wiring conduit elbow is not the proper type. Should be repaired.

improper connection to junction box.

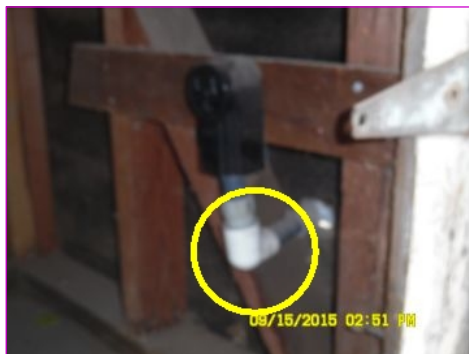
Improper pvc type for electrical

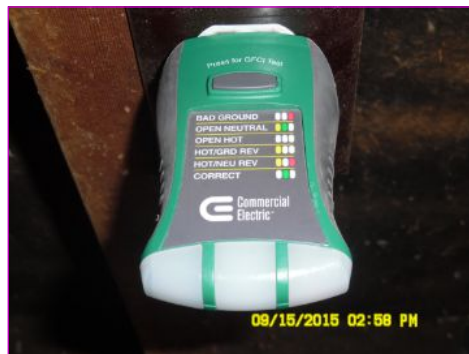
garage has grounded outlets installed but no ground found.

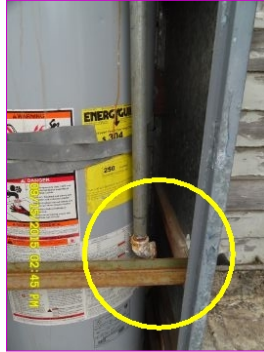
- The discharge pipe of this water heater temperature/pressure relief (TPR) valve was terminated more than 6 inches above the floor. This condition could result in scalding if the pressure relief valve were activated while a person was nearby. The Inspector recommends correction.

discharge pipe too high off ground.

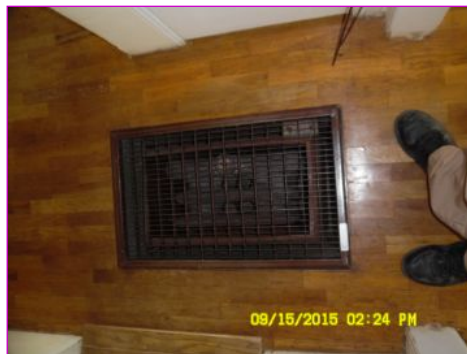
- This furnace was an older, gas-fired, low-efficiency, gravity furnace. This type of furnace has air supply ducts through which air rises naturally as it is heated. Air returns through floor registers to be reheated. No return air ducts were installed.

Original floor furnace

- The Inspector recommends that furnace cleaning, service and certification be performed by a qualified HVAC contractor.

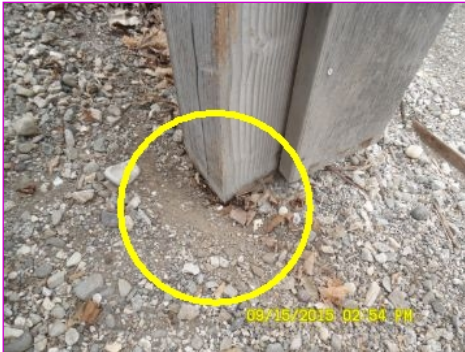
- **Fence had posts that had failed due to decay. The fences were leaning in these areas.**

gate post rotted.

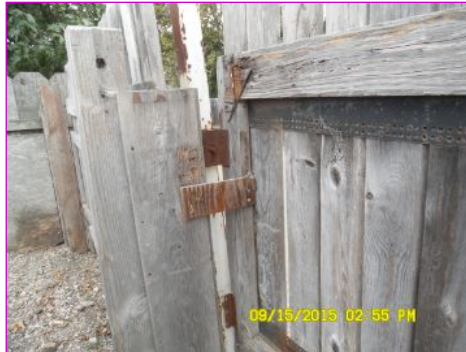
rolling gate is unprofessional installed and unsafe.

- **The gates appeared to be at or near the ends of their useful lives at the time of the inspection. The Inspector recommends that you consult with a qualified contractor to discuss options and costs for correction. Rear sliding gate was not installed professionally and could pose a safety hazard.**

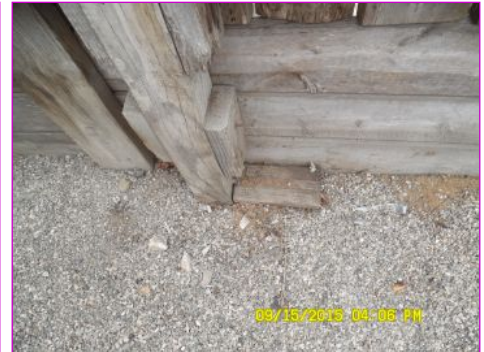
rotted fence post

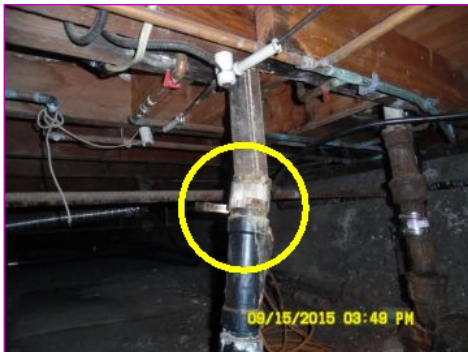
- **Drain, waste and/or vent pipes visibly leaking in the crawlspace at the time of the inspection should be repaired to prevent the development of unhealthy conditions.**

connector clamp broken

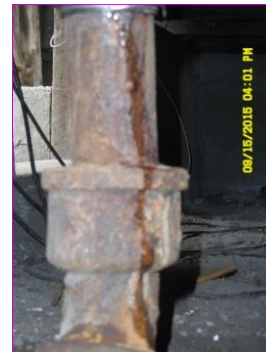
drain pipe leaking

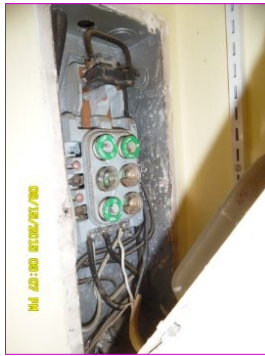
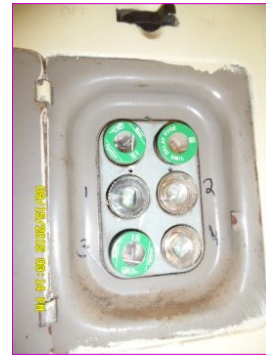
SERVICE PANEL Service Panel General Condition

- The service panel was old and obsolete. The Inspector strongly recommends replacement.

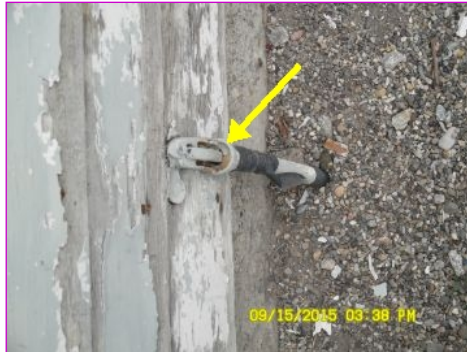
- A junction box installed at the home exterior was missing a cover and energized electrical components were exposed to touch. This condition is an electrical shock/electrocution hazard. The inspector recommends that a proper cover be installed.

elbow needs cover.

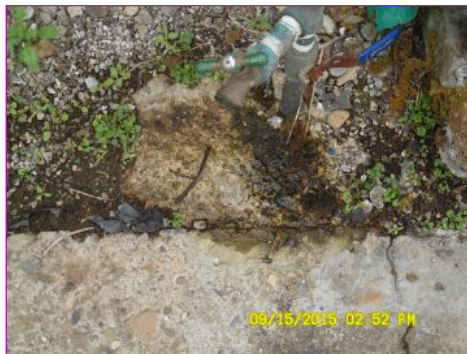
- An exterior faucet near the garage exterior was leaking. The Inspector recommends repair.
- An exterior faucet at the front of the house was leaking. The Inspector recommends repair by.

leaking faucet

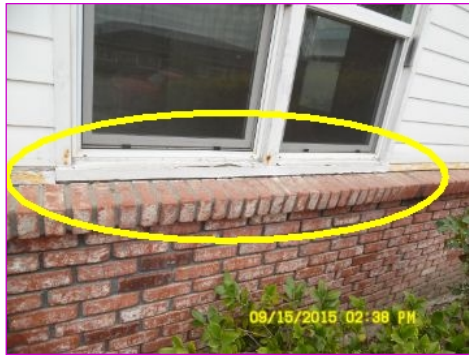
needs to be sealed up

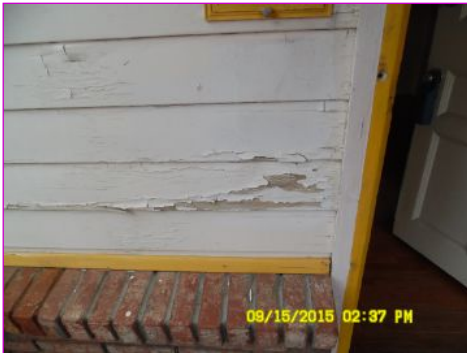
• Finish coating designed to protect the wood siding was severely deteriorated at the time of the inspection. The Inspector recommends that you consult with a qualified painting contractor to discuss options and costs for installing a new protective finish coating.

Most all of exterior needs painting.

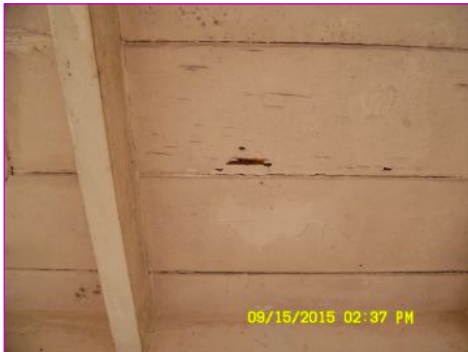
- wood under eave was damaged in places. The Inspector recommends repair.

water/insect damage to wood planks

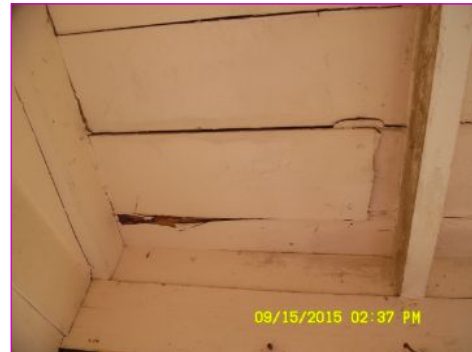
water/insect damage to wood planks

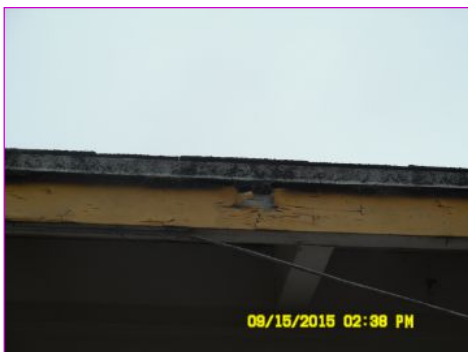
- Home fascia was damaged in places. The Inspector recommends repair.

Most all of exterior needs painting

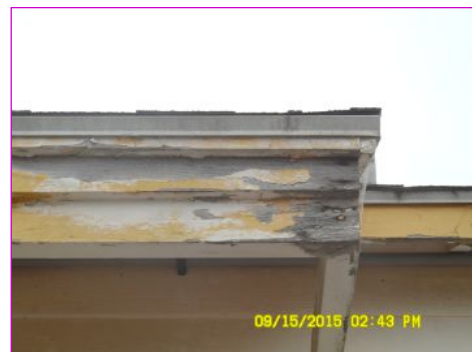
water damage.

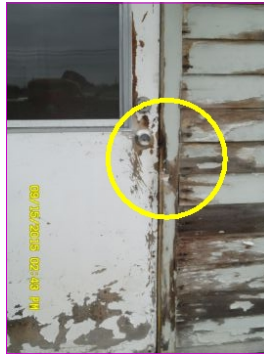
- **Door trim was damaged and needed repair at the time of the inspection.**

laundry room door trim

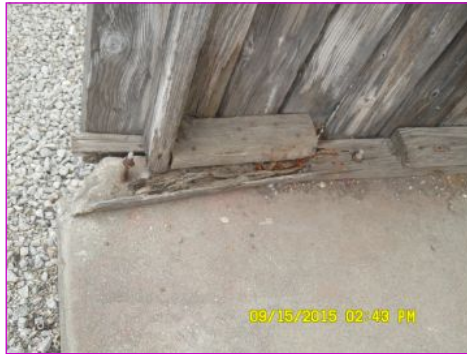
- **At the time of the inspection, the porch guardrail assemblies exhibited severe damage or deterioration. This is an unsafe condition. The Inspector recommends that you consult with a qualified contractor to gain an idea of options and costs for repair or replacement.**

porch wood rotted.

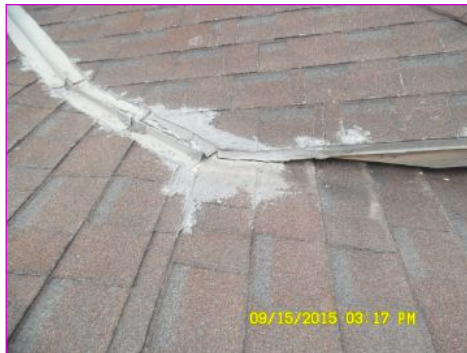
ASPHALT SHINGLES General Condition

• Asphalt composition shingles covering the roof of this home exhibited moderate general deterioration commensurate with the age of the roof. They appeared to be adequately protecting the underlying home structure at the time of the inspection.

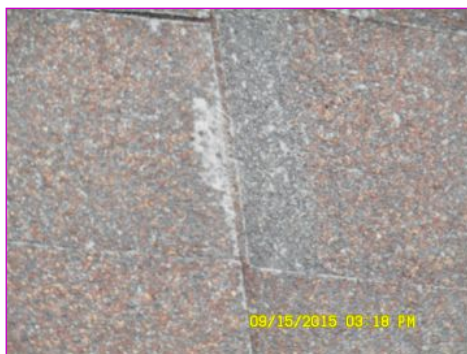
• Asphalt shingles were old and had suffered noticeable uniform granule loss across the roof. This is not a defective condition, but is a natural result of the aging process. The bond between asphalt and granules deteriorates over time as asphalt loses volatile compounds, dries and shrinks. It does not affect the ability of the shingles to shed water.

Granules wearing off on south side of roof.

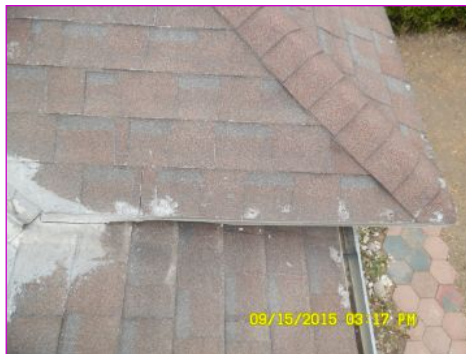
- **Some asphalt shingles on the roof had fasteners visible. Exposed fasteners are considered by shingle manufacturers to be temporary repairs. This condition is typical of efforts to prevent wind damage to poorly bonded shingles.**

roof fasteners exposed all around roof edge.

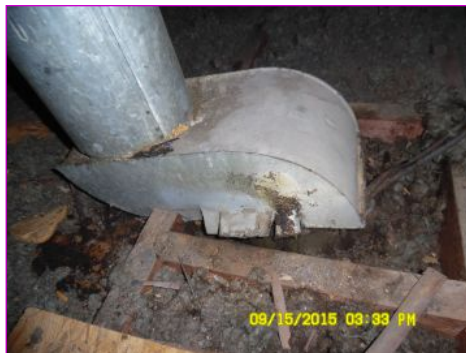
stove vent duct vent needs securing

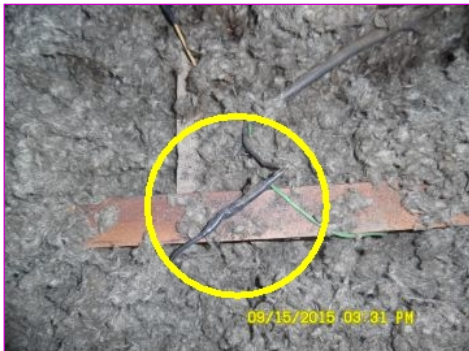
- Energized electrical splices not contained within a junction box and exposed to touch were visible in the attic at the time of the inspection. Electrical splices should be contained within an approved junction box with a cover plate installed. This condition is a shock/electrocution and potential fire hazard and should be corrected.

wiring junction not in box.

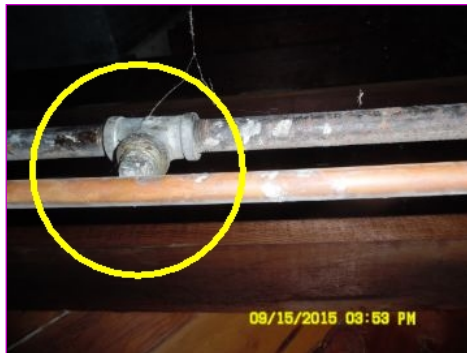
gas pipe rubbing on water pipe.

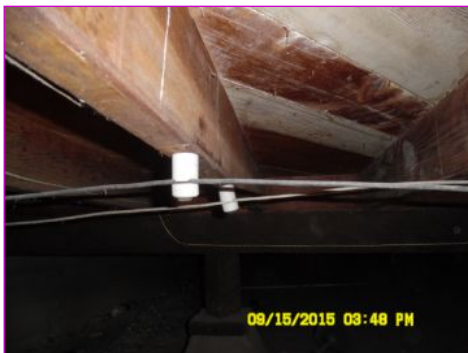
Wires should be terminated in an approved junction box with a cover installed by a

knob and tube wiring present in crawlspace.
