Left Coast Inspections Property Inspection Report

, CA Inspection prepared for: Date of Inspection: 3/2/2018

Inspector: Darrell Clegg

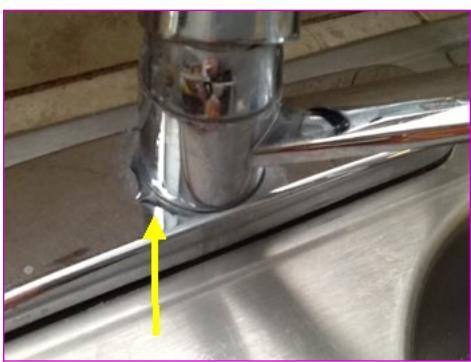
• The kitchen faucet base leaked when water was turned on. The Inspector recommends repair/replace.

Faucet leaks at base.

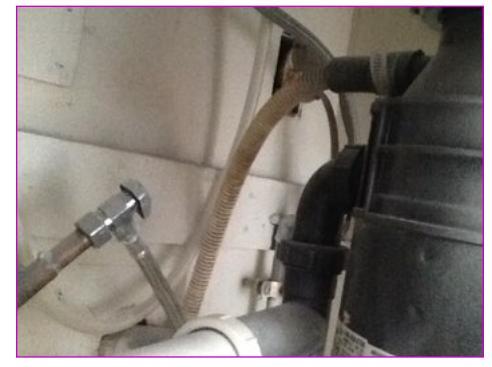
• The dishwasher did not have an Air Gap installed in the drain line at the time of the inspection. The Air Gap is designed to prevent wastewater from contaminating the water supply.

No air gap present.

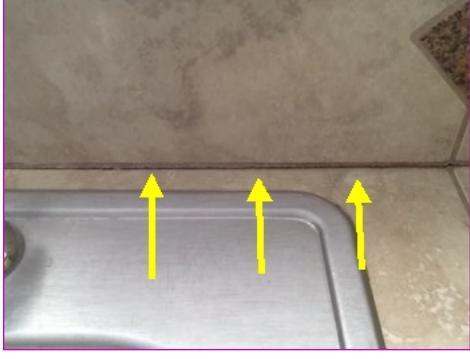
• At the time of the inspection, the Inspector observed few deficiencies in the condition of the kitchen countertops. Notable exceptions will be listed in this report.

suggest caulking here

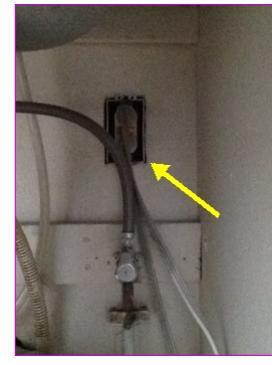
• In the kitchen an electrical receptacle was missing a cover plate. This condition left energized electrical components exposed to touch. This shock/electrocution hazard should be corrected. (Under sink)

Missing cover plate

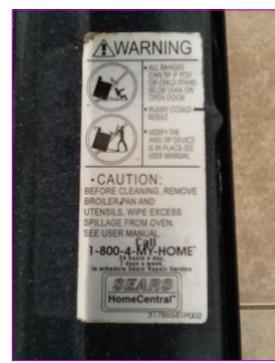
• The range was not fastened to the floor. A child standing on the open oven door could overturn the range. This condition is a life-safety issue. The Inspector recommends installation of an approved anti-tip device.

no anti-tip device installed

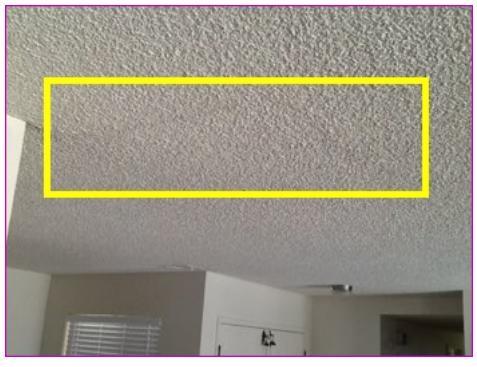
past crack patched

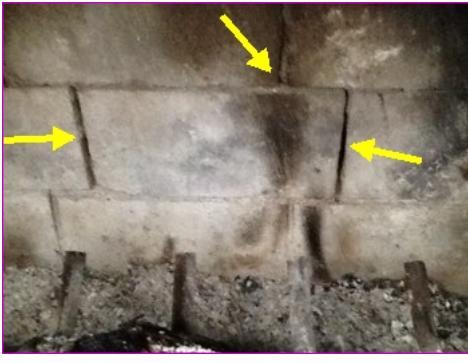
• Firebrick lining the wall of the firebox of the wood-burning fireplace in the living room was cracked. This condition may allow the toxic, corrosive products of combustion to damage the chimney structure or enter the living space. The Inspector recommends repair.

Mortar is missing, brick is loose.

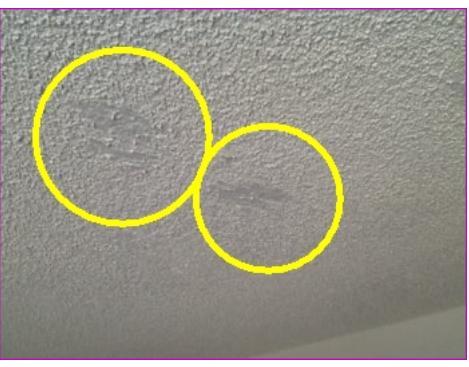
• Minor damage to the ceiling was visible in this bedroom at the time of the inspection.

poorly completed repairs

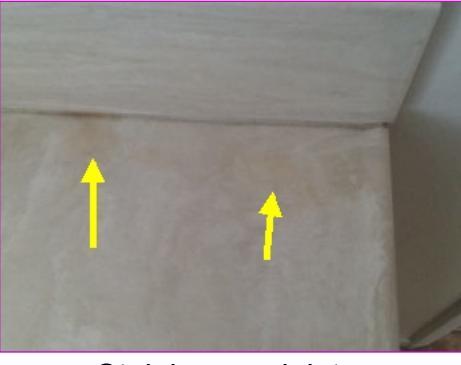
The countertop in this bathroom had minor damage.

Staining on sink top

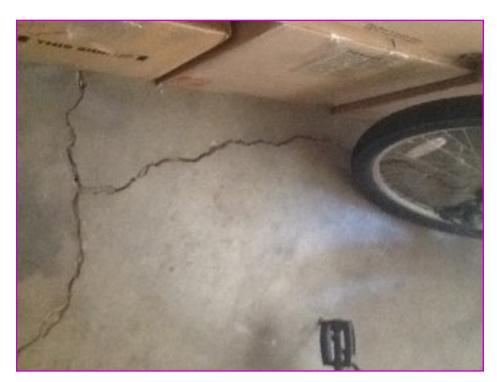
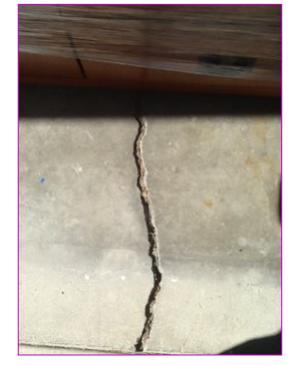
• Severe cracking was visible in the garage floor at the time of the inspection. This type of cracking is typically caused by soil movement. The Inspector recommends evaluation by a structural engineer to determine the degree to which this condition is likely to continue and to discuss options for correction or stabilization.

Cracks over 1/2" in garage floor.

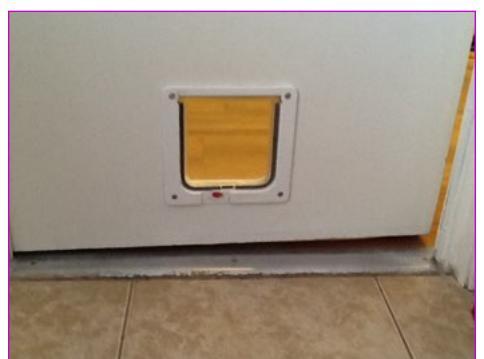
• The door from the garage to the living areas fire rating was void due to a pet door being installed. Recommend replacement of the door to maintain a fire rating.

pet door voids fire rated door.

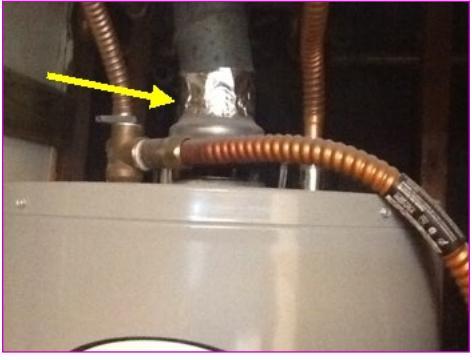
• Water heater exhaust flue vent connections require screws. Suggest this be repaired.

vent pipe needs screws at connections

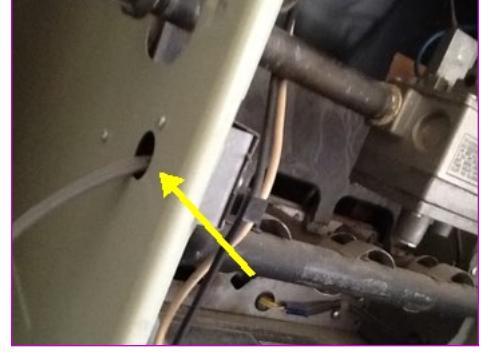
• Non-metallic conductors passed through knock-outs in the furnace that had no protective device installed. Connectors designed to protect conductors where they pass through sheet metal include busings, cable clamps, grommet, or other connectors. Without some protective device, the sharp edges of sheet metal may damage the conductors. This condition is a potential a shock/electrocution or fire hazard. The Inspector recommends that protective devices approved for this purpose be installed.

missing grommet/wire clamp here

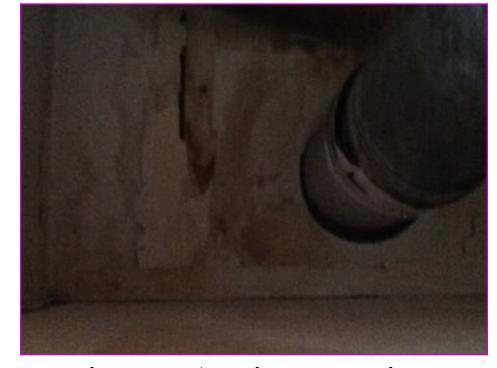
previous water damage, dry now

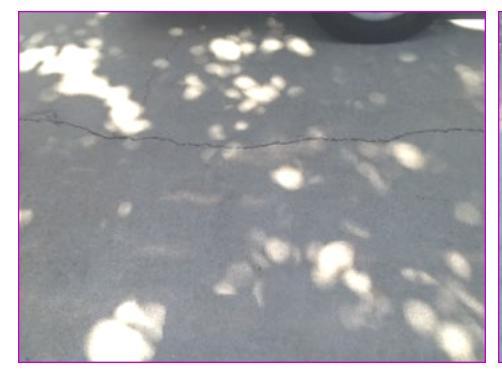
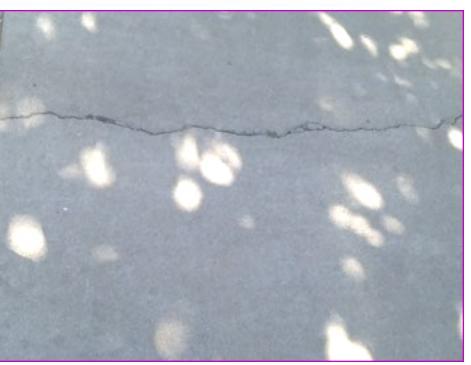
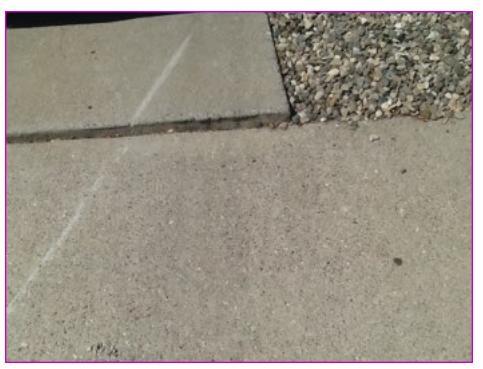
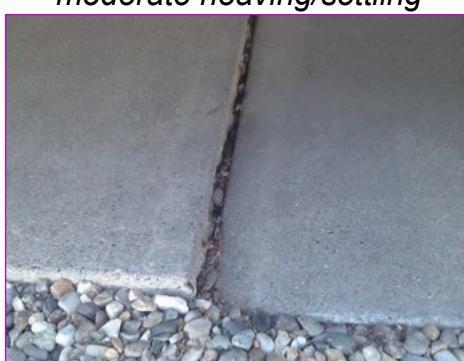
• Severe heaving of soil beneath the driveway has created trip hazards that should be corrected by a qualified contractor.

moderate heaving/settling

Driveway trip hazard.

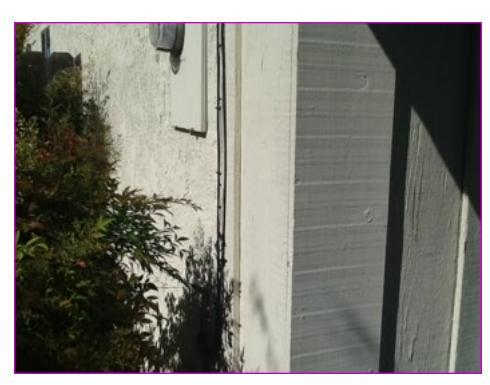
• The service panel did not have proper clearances to provide quick access for an emergency disconnect due to overgrown or poorly placed vegetation. This condition should be corrected. The clear working space required in front of a panel is 30" wide by 36" deep with a minimum headroom clearance of 6 feet-6 inches.

Vegetation obstructs panel access

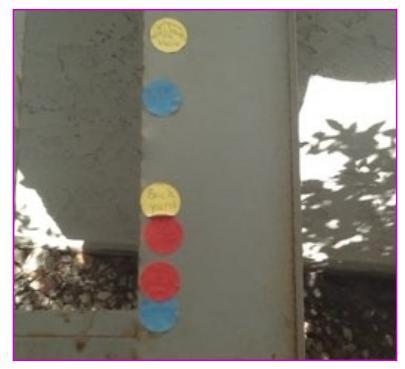
• The branch Circuit Directory label of the service panel was missing and circuits were identified by markings on the face of the dead front cover.

Electrical not labeled well

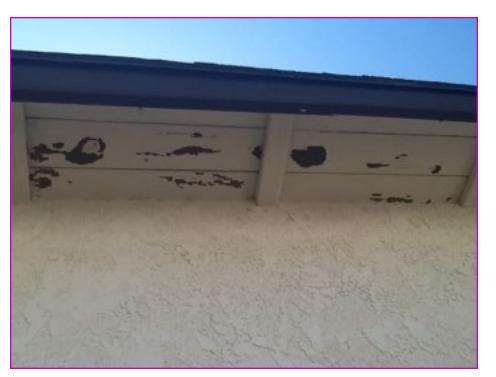
• Soffits had large areas of chipped paint. Suggest painting these areas for proper wood protection.

flaking paint east side eaves.

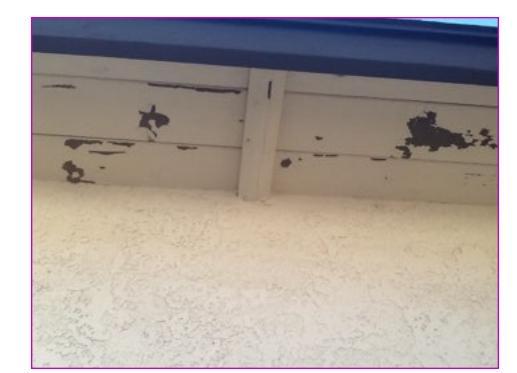
flaking paint east side eaves.

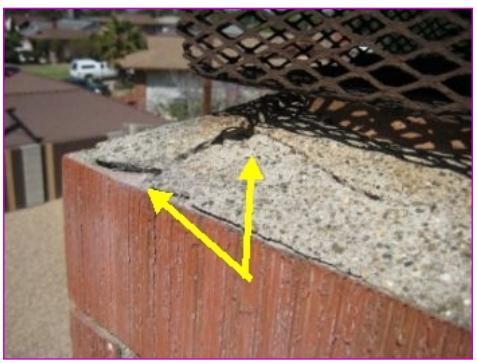
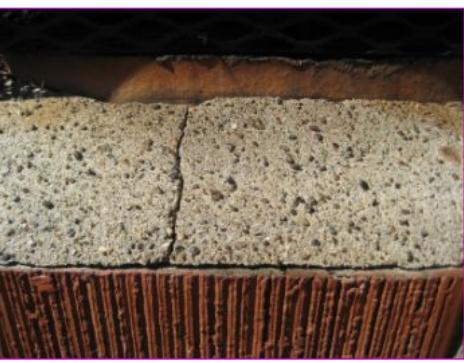
• Minor cracking was visible in the chimney crown. Suggest sealing these cracks.

cracks need sealing

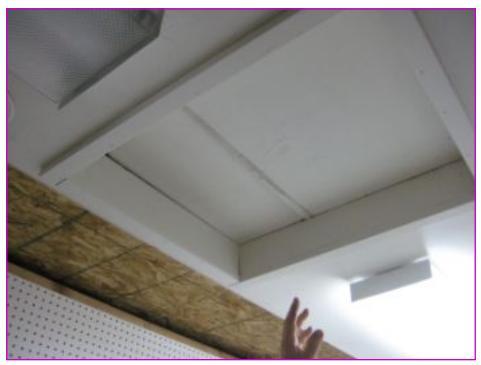
- The Inspector evaluated the attic from inside the attic space.
- The attic was accessed through a hatch in a bedroom closet ceiling.
- Access panel was broken. Suggest repair.

access panel broken.

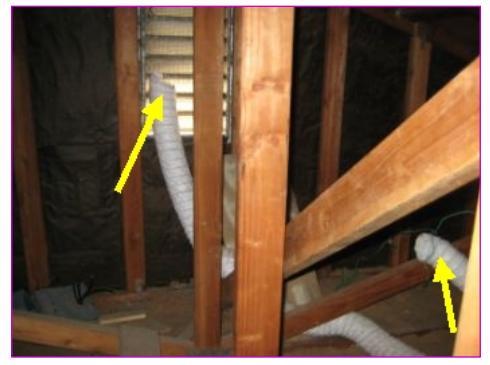
• Room vent ducts were pointed towards the gable vent. This is not sufficient for proper removal of moisture from the bathrooms. Suggest directly venting these ducts to the exterior. Each bathroom should have its own exterior termination.

vents from both bathrooms not ducted to outside.

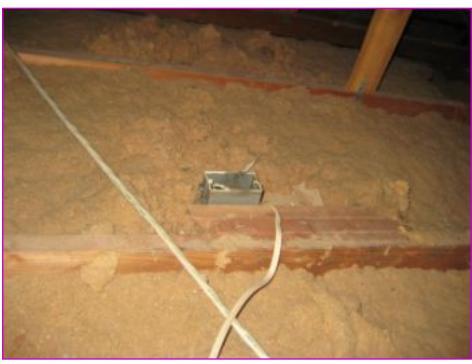
• One or more junction boxes visible in the attic were missing cover plates at the time of the inspection, leaving energized electrical components exposed to touch. This condition is a shock/electrocution and potential fire hazard. The Inspector recommends that listed cover plates be installed.

Missing junction box cover.

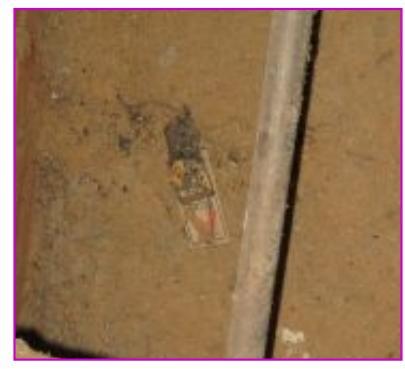
• A rodent carcass was noted in the attic and should be removed by a qualified pest control professional.

Mouse carcass
