Left Coast Inspections

Property Inspection Report

Inspection prepared for:
Date of Inspection: 6/26/2017

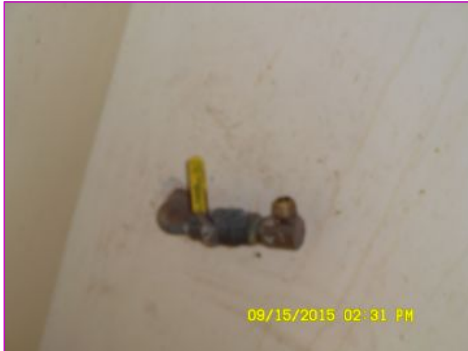
gas shut off

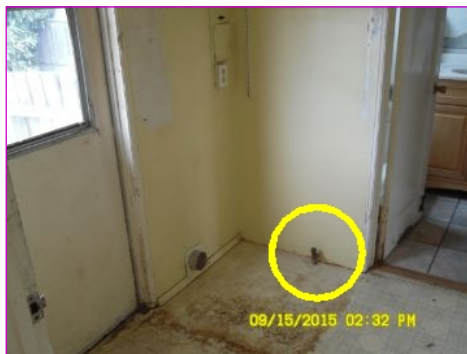
Gas line capped off. No shut off installed

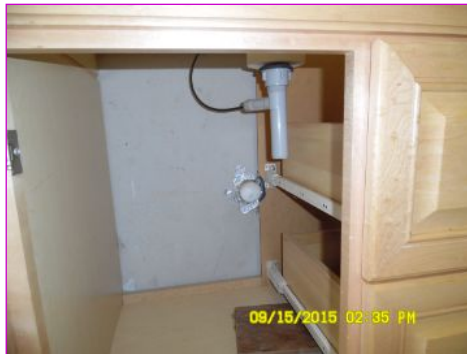
- the sink drain was not connected. Unable to test operation.

sink/faucet not completely installed

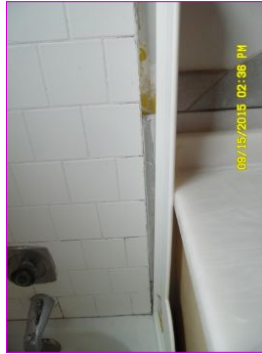
tile edge not finished

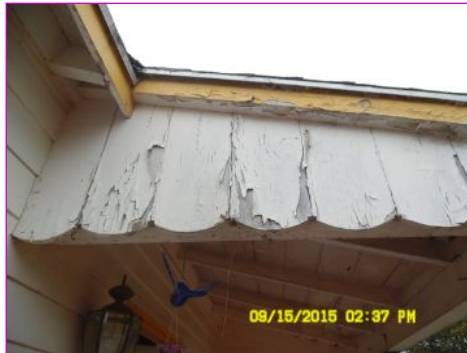
Most all of exterior needs painting

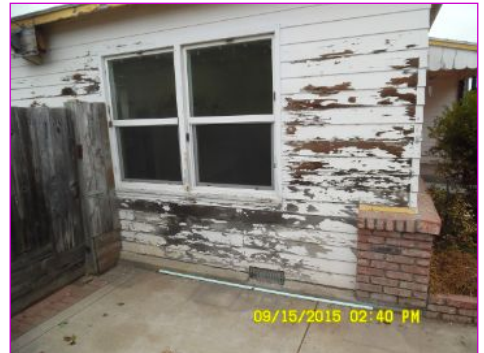
Most all of exterior needs painting

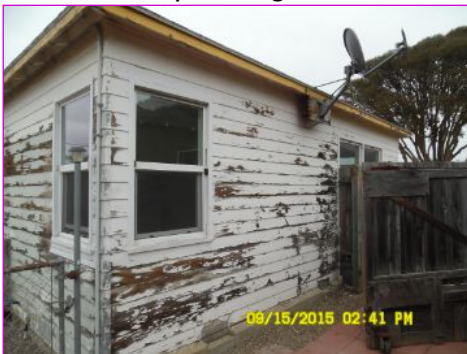
Most all of exterior needs painting

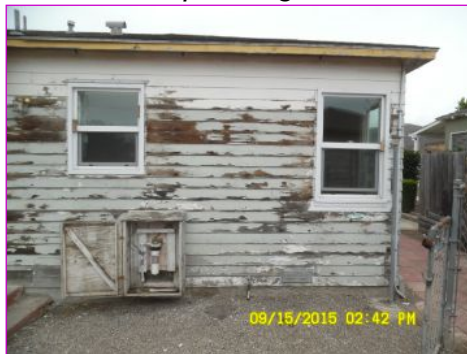
Most all of exterior needs painting

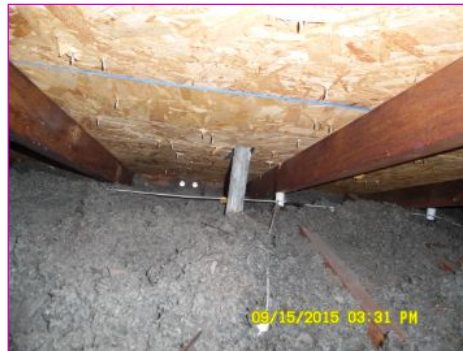
knob and tube wiring present in attic space.

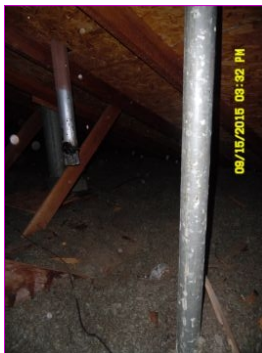
galvanized plumbing vent
