Left Coast Inspections

Property Inspection Report

Inspection prepared for:
Date of Inspection: 6/26/2017

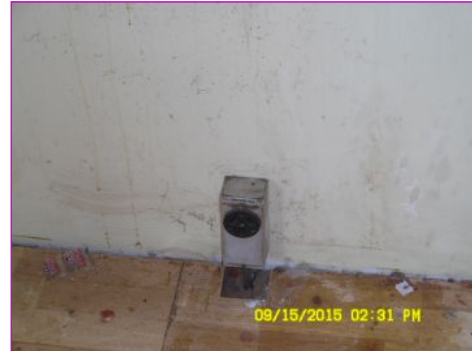
220V outlet

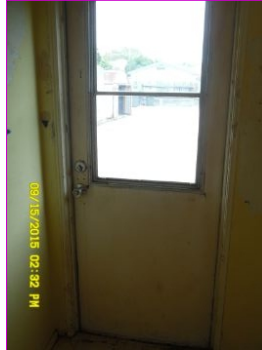
- The door the exterior in the laundry room was severely damaged and/or deteriorated and will need replacement. The Inspector recommends that you consult with a qualified contractor to discuss options and costs for replacement.

Door deteriorated.

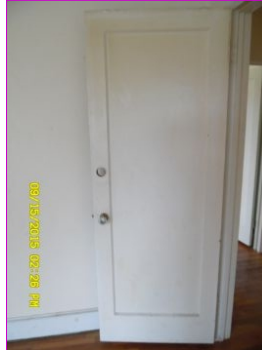
Observations: Door hardware was broken at an interior door in this bedroom. The Inspector recommends service by a qualified contractor.

deadbolt missing

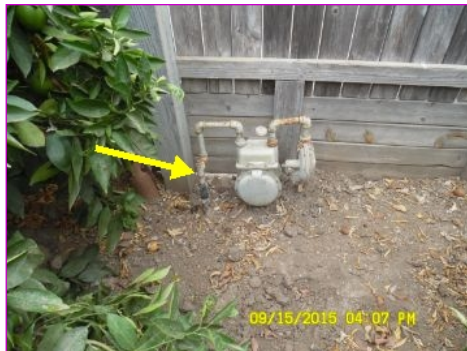
- The main gas shut-off was located at the gas meter located at the rear of the home.

next to alley fence.

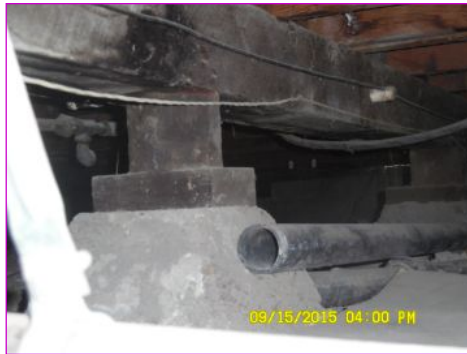
FOUNDATION Footings

- The home appeared to have a continuous poured concrete footing. The footings were only partially visible at the time of the inspection. The majority of the footings were buried in soil.
